**ENQUIRY REPORT  
ICE INCURSION INCIDENT *SEAROSE* FPSO  
July 26, 2018**

**Prepared by:**  
**Veronica Warren, C-NLOPB Safety Officer**  
**Assisted by:**  
**John Pennell, C-NLOPB Environmental Compliance Officer; and**  
**Darrell Gover, C-NLOPB Environmental Compliance Officer**

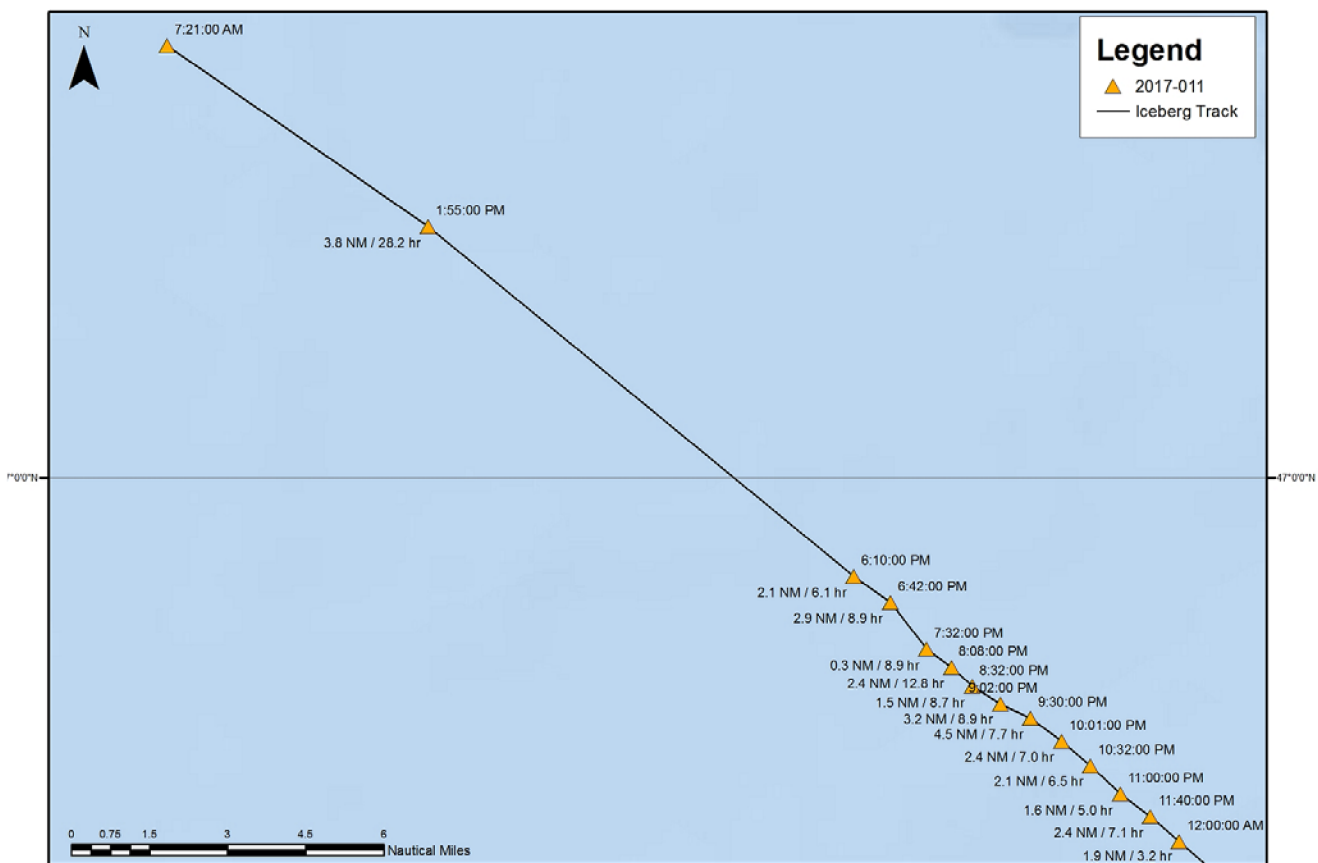
Iceberg 2017-011 Drift Track  
CPA / TCPA - Tuesday, March 28, 2017

Late on the morning of March 28, 2017, the *M/V Maersk Dispatcher* was tasked to sail north to find and monitor a newly identified iceberg named berg 011. At 1800 hrs the *M/V Maersk Dispatcher* was positioned near berg 011 and began monitoring its track. The track of berg 011 for March 28, 2017, is provided in Figure 2. The *SeaRose* requested the *M/V Maersk Dispatcher* take berg 011 under tow. The vessel, however, was unable to carry out this request due to the weather conditions and sea states at the time.

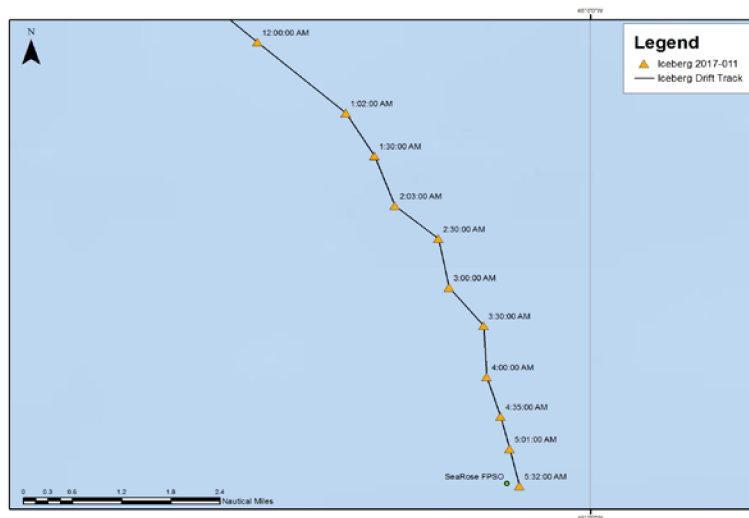
Iceberg 2017-011 Drift Track  
March 29, 2017

At 0542 hrs the RRMT/NSO, Vice President of Operations from Husky called Dan Chicoyne, the C-NLOPB Acting Chief Safety Officer, to report that they managed to maneuver the berg (medium sized) past the *SeaRose*. It came within 50-100m. They would continue to push it further with water cannons but felt the danger had passed and did not plan to disconnect.

At 0605 hrs the HSEQ Coordinator Drilling and Completions from the RRMT called Veronica Warren, the C-NLOPB Duty Officer, and advised that the iceberg was outside the 500 m zone.

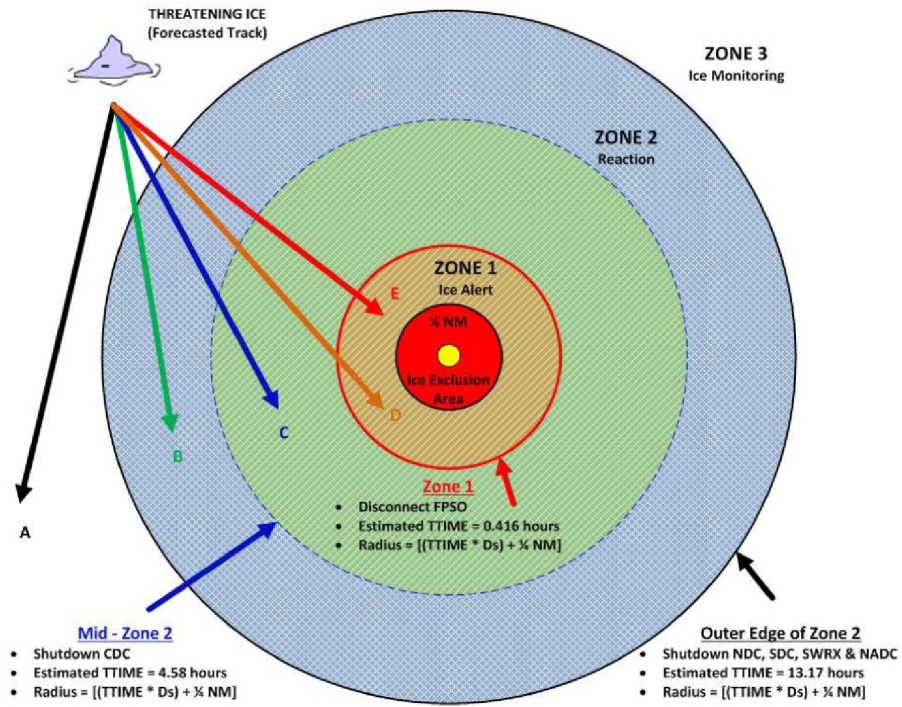
Figure 5: Iceberg Forecasted Track

The *SeaRose*, however, remained connected. There was no evidence provided to the enquiry team to indicate that it was recognized at approximately 0500 hrs berg 011 entered Zone 1 on path E (Figure 5). It was noted that the OIM was receiving conflicting information as to whether berg 011 was under tow or not. This is further discussed in the Analysis of the RRMT Call Logs section of this report.

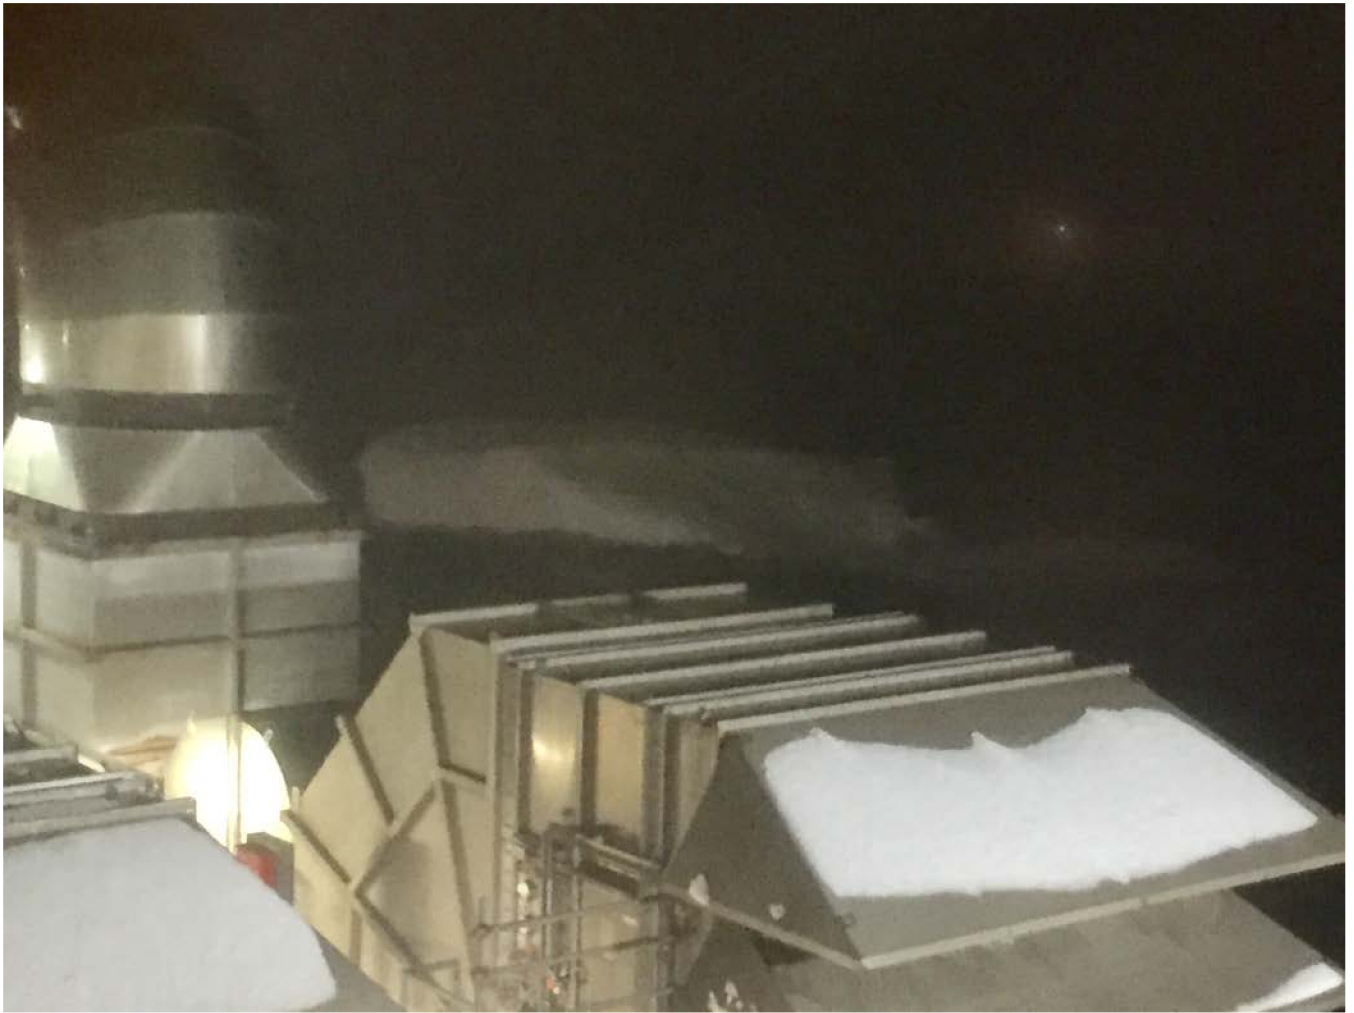
Berg 011 (Taken from *SeaRose* at 0525 hrs March 29, 2017)

Berg 011 was a tabular small sized iceberg that was sloped on one side. Its dimensions were estimated by the *SeaRose*'s Ice Observer to be 60m x 40m x 8m. The enquiry team calculated berg 011's mass to be roughly between 57,600 t to 68,400 t and estimated its draft to be 50 m (calculations are provided in Appendix 1 and based on IMP methodology). A picture of berg 011, taken from the *SeaRose*, is provided in Appendix 2.

The Serviceability Criteria, incorporated in the IMP limit icebergs to waterline lengths of 20 m or less with a maximum wave height of 2.5 m so as to minimize the risk of contact with the bilge keels. Berg 011's water length exceeded these conditions as did the wave heights at the time. If berg 011 had made contact with a bilge keel some damage would have occurred. The enquiry team is not able to specify the amount of damage or the significance of the damage.

With a draft estimated to be 50 m, berg 011 had the potential to contact the hog bends of risers in its path as the hog bends have depths ranging from 46 to 56 m. If a riser was damaged there would be the possibility of loss of residual hydrocarbon left after flushing. The volume lost would not be significant and would disperse readily given the conditions at the time. Even if the *SeaRose* disconnected, the risk of berg 011 contacting one of the risers would not change significantly.

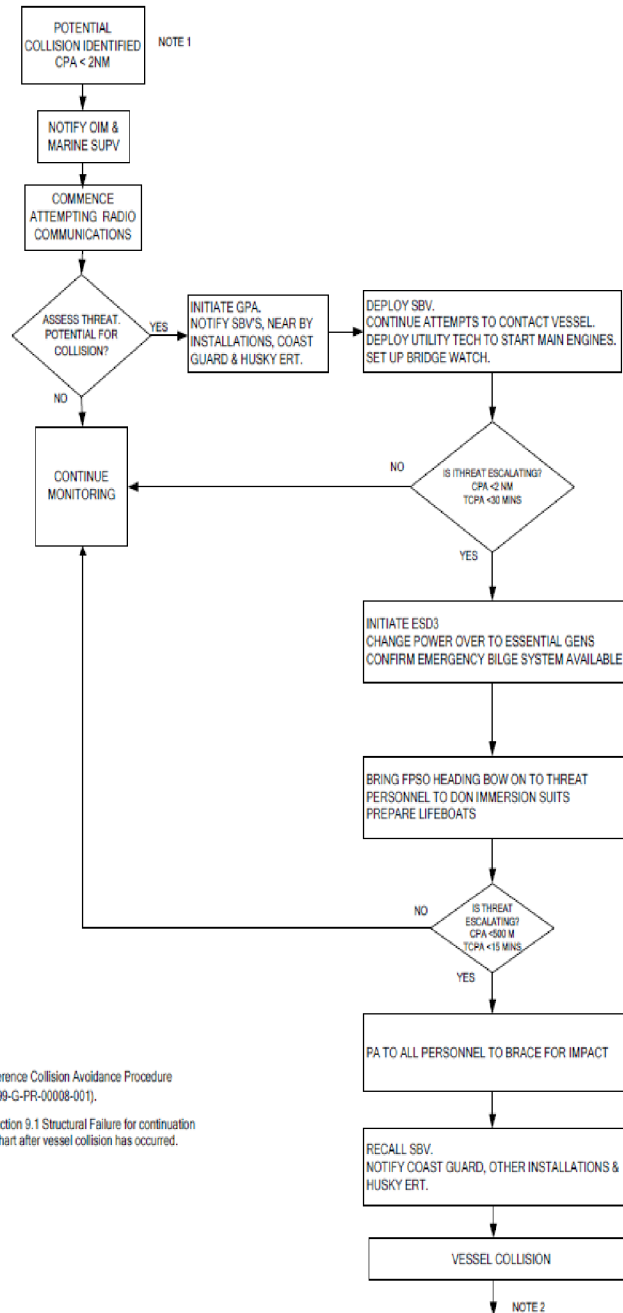
## 9.15 Vessel Collision Avoidance

The enquiry team noted that the IMP was not utilized by the *SeaRose*'s ECC. The *SeaRose* ECC utilized the *HaBERS* scenario (flowchart) for Vessel Collision Avoidance (Appendix 4) which does not provide direction on actions required as an iceberg enters the ice zones. This scenario also does not provide direction to disconnect the *SeaRose* from the buoy. Upon review of the *HaBERS*, the enquiry team noted that there is no scenario for iceberg threats.

- b) The *SeaRose* ECC team uses a document called *Hazard-based Emergency Response Scenarios (HaBERS)* as a guide during emergencies and training, as it outlines actions to be taken for the management of predetermined incident scenarios. It is noted that there is no iceberg emergency scenario in *HaBERS*. *HaBERS* directs personnel to the *Ice Management Plan* for potential iceberg collision; which as stated above is cumbersome unless familiar with the plan. The ECC team being accustomed to using *HaBERS* defaulted to the Vessel Collision Avoidance scenario (used for vessels) which does not reference actions to be taken as icebergs enter zones with particular tracts and does not direct the OIM to disconnect;
