# Using Digital Data to Reduce Subsea Risks

Kathy Mercer-White  
January 13, 2021

November 16, 2018 – spill occurred near the South White Rose Extension (SWRX) Drill Centre

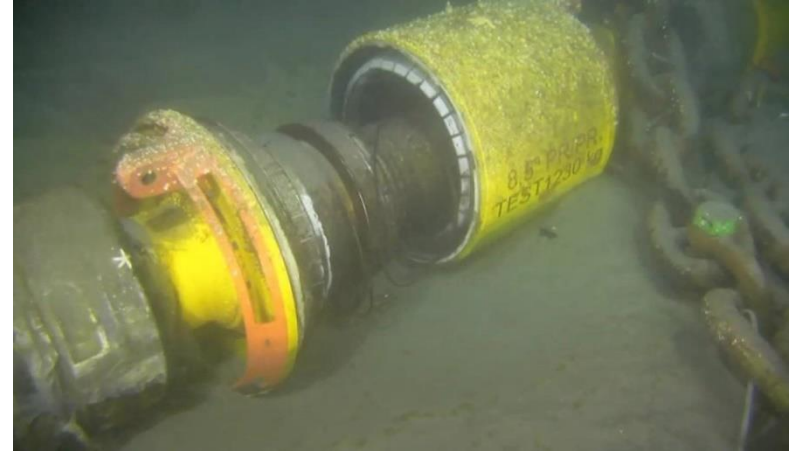
The source was a separated subsea flowline connector

Our investigation determined the primary cause was due to hydrate development in the flowline connector

Separated flowline connector near SWRX
