SWRX Spill

Jonathan Brown
December 3, 2019

Oil Spill From South White Rose Extension (SWRX)

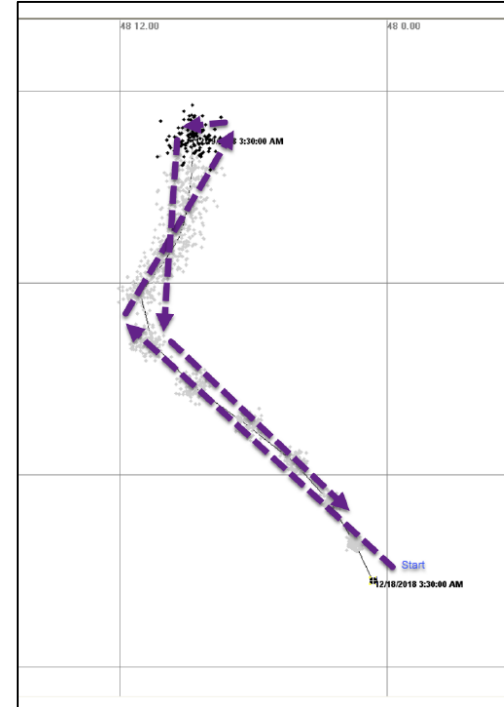
Daily monitoring by supply vessels
