C-NLOPB Spill Response and Lessons Learned Forum

Karen Kelly, General Manager - East Coast Assets
December 3, 2019

2004 Oily Water Discharge from the Terra Nova FPSO

2018 Unauthorized Discharge of SBM from the Transocean Barents

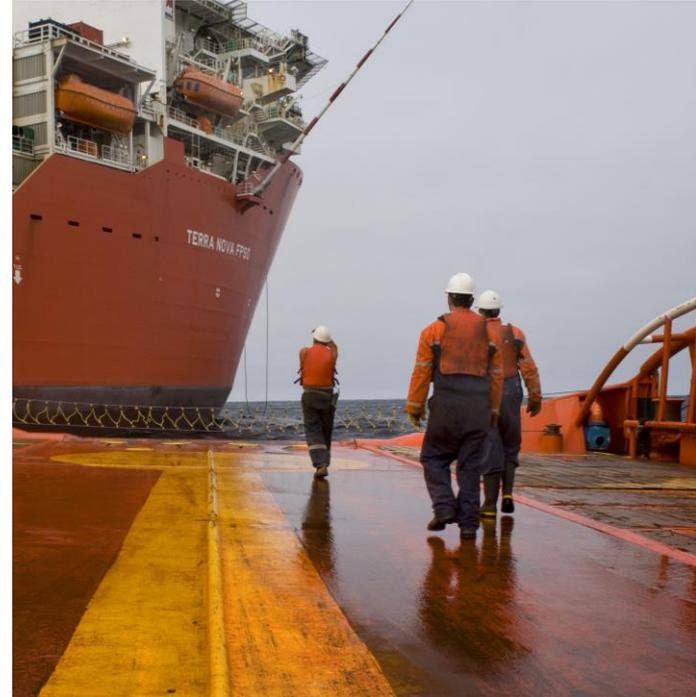
- On November 21, 2004, an oil sheen was observed near the Terra Nova FPSO
- Investigation revealed that water mixed with oil had been discharged through the produced water caisson
- Approximately 165 m³ of oil was released

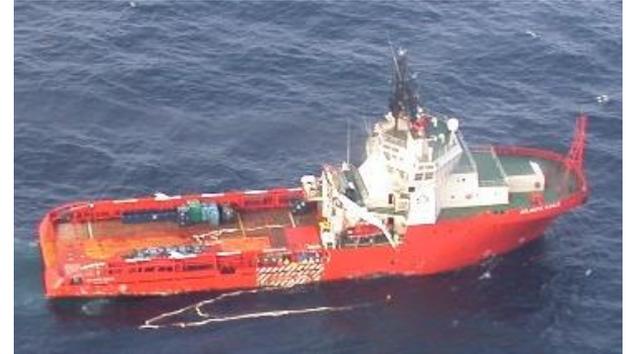
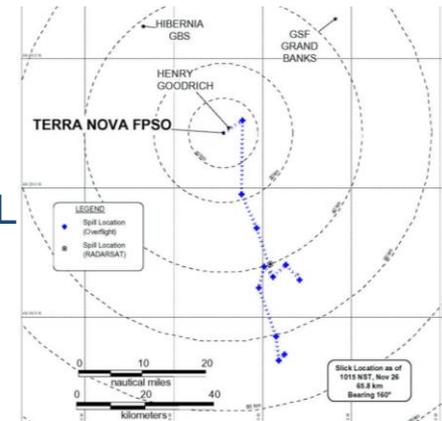
- Immediate shut in of all production
- Activation of Petro-Canada's **Emergency Response Plan**
- Multiple vessels engaged in **recovery** by conducting booming and skimming
- **Monitoring** through water sampling
- **Wildlife monitoring** through on-vessel observers and seabird centres
- **Sheen tracking** through tracker buoys, trajectory modelling and aerial surveillance
- Subject matter expertise **support** provided through ECRC and OSRL
- Status updates through regular communication with external parties
 - Regulator and government agencies
 - One Ocean
 - Media

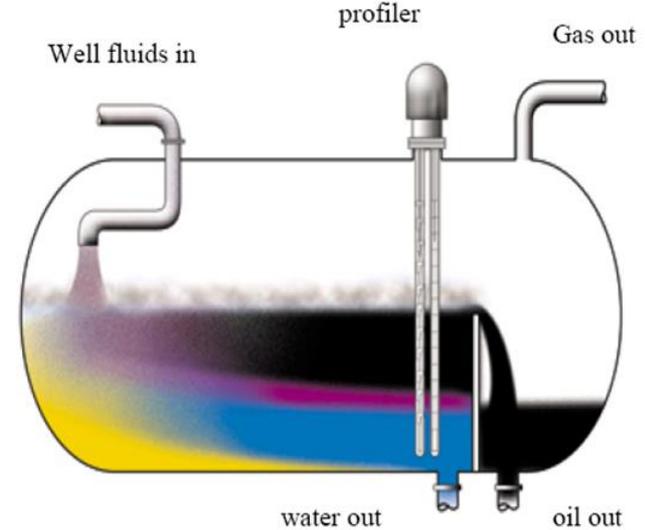
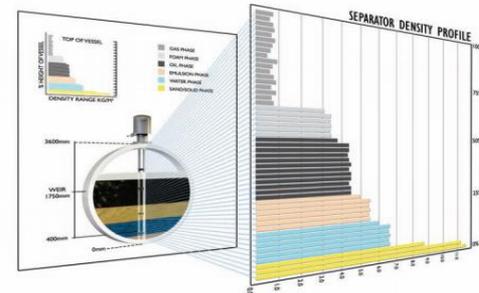
- Installation of nucleonic profilers to allow visibility of the fluids within the separators
- Replacement of chemical injection system to prevent formation of emulsion within the separators
- Upgrade of interface level instruments to distinguish between fluids within the separators
- Improvements to the alarm management process
- Upgrades to oil-in-water analyzer system to allow continuous monitoring and trending

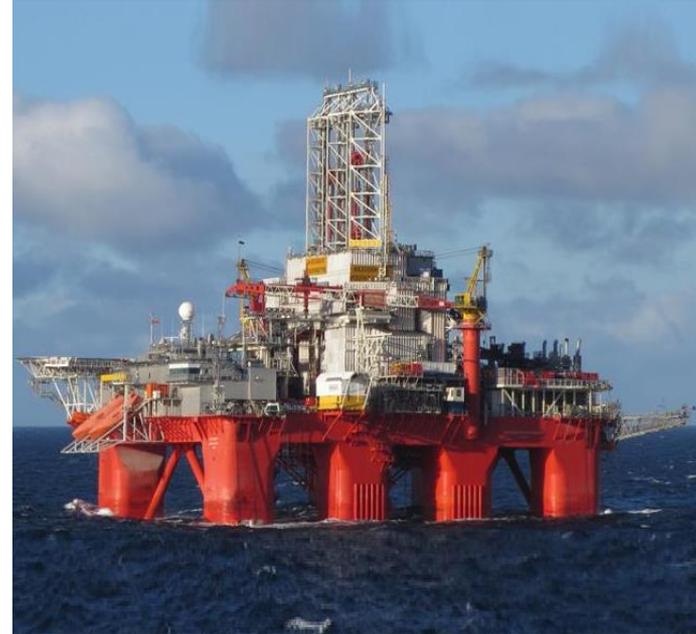
On April 27, 2018, approximately 28 m³ of SBM was discharged from the Transocean Barents MODU

- Synthetic-based mud (SBM) used in our drilling operations is non-toxic to humans/wildlife and is more biodegradable than other drilling fluids
- The rig commenced displacement of cement with SBM when a loss of SBM was identified based on an observed drop in active volume
- Measures were immediately taken to stop the discharge and rig operations were stopped until CNLOPB approval to resume operations was received on May 3, 2018

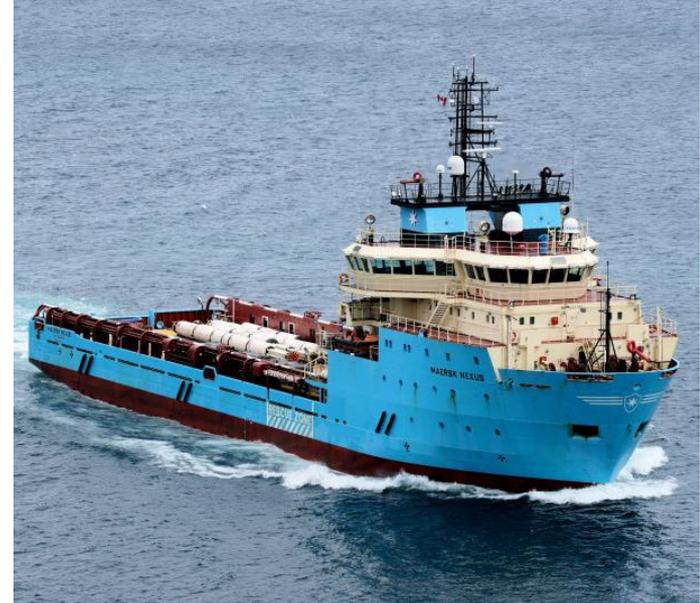
- **Inspections** conducted by offshore supply vessel, *Maersk Nexus*, and did not identify a visible sheen in the water
- **Wildlife monitoring** by supply vessels
- Oil spill booms were not deployed as SBM is heavier than water and rapidly sinks in water
- **Subsea survey** was conducted by a remotely operated vehicle (ROV) to assess potential subsea effects
