**Baseline Hydrogeological
Characterization
Concrete Gravity Structure
Graving Dock Site
Argentia, NL**

Final Report

File No. 121412512

Date: April 10, 2013

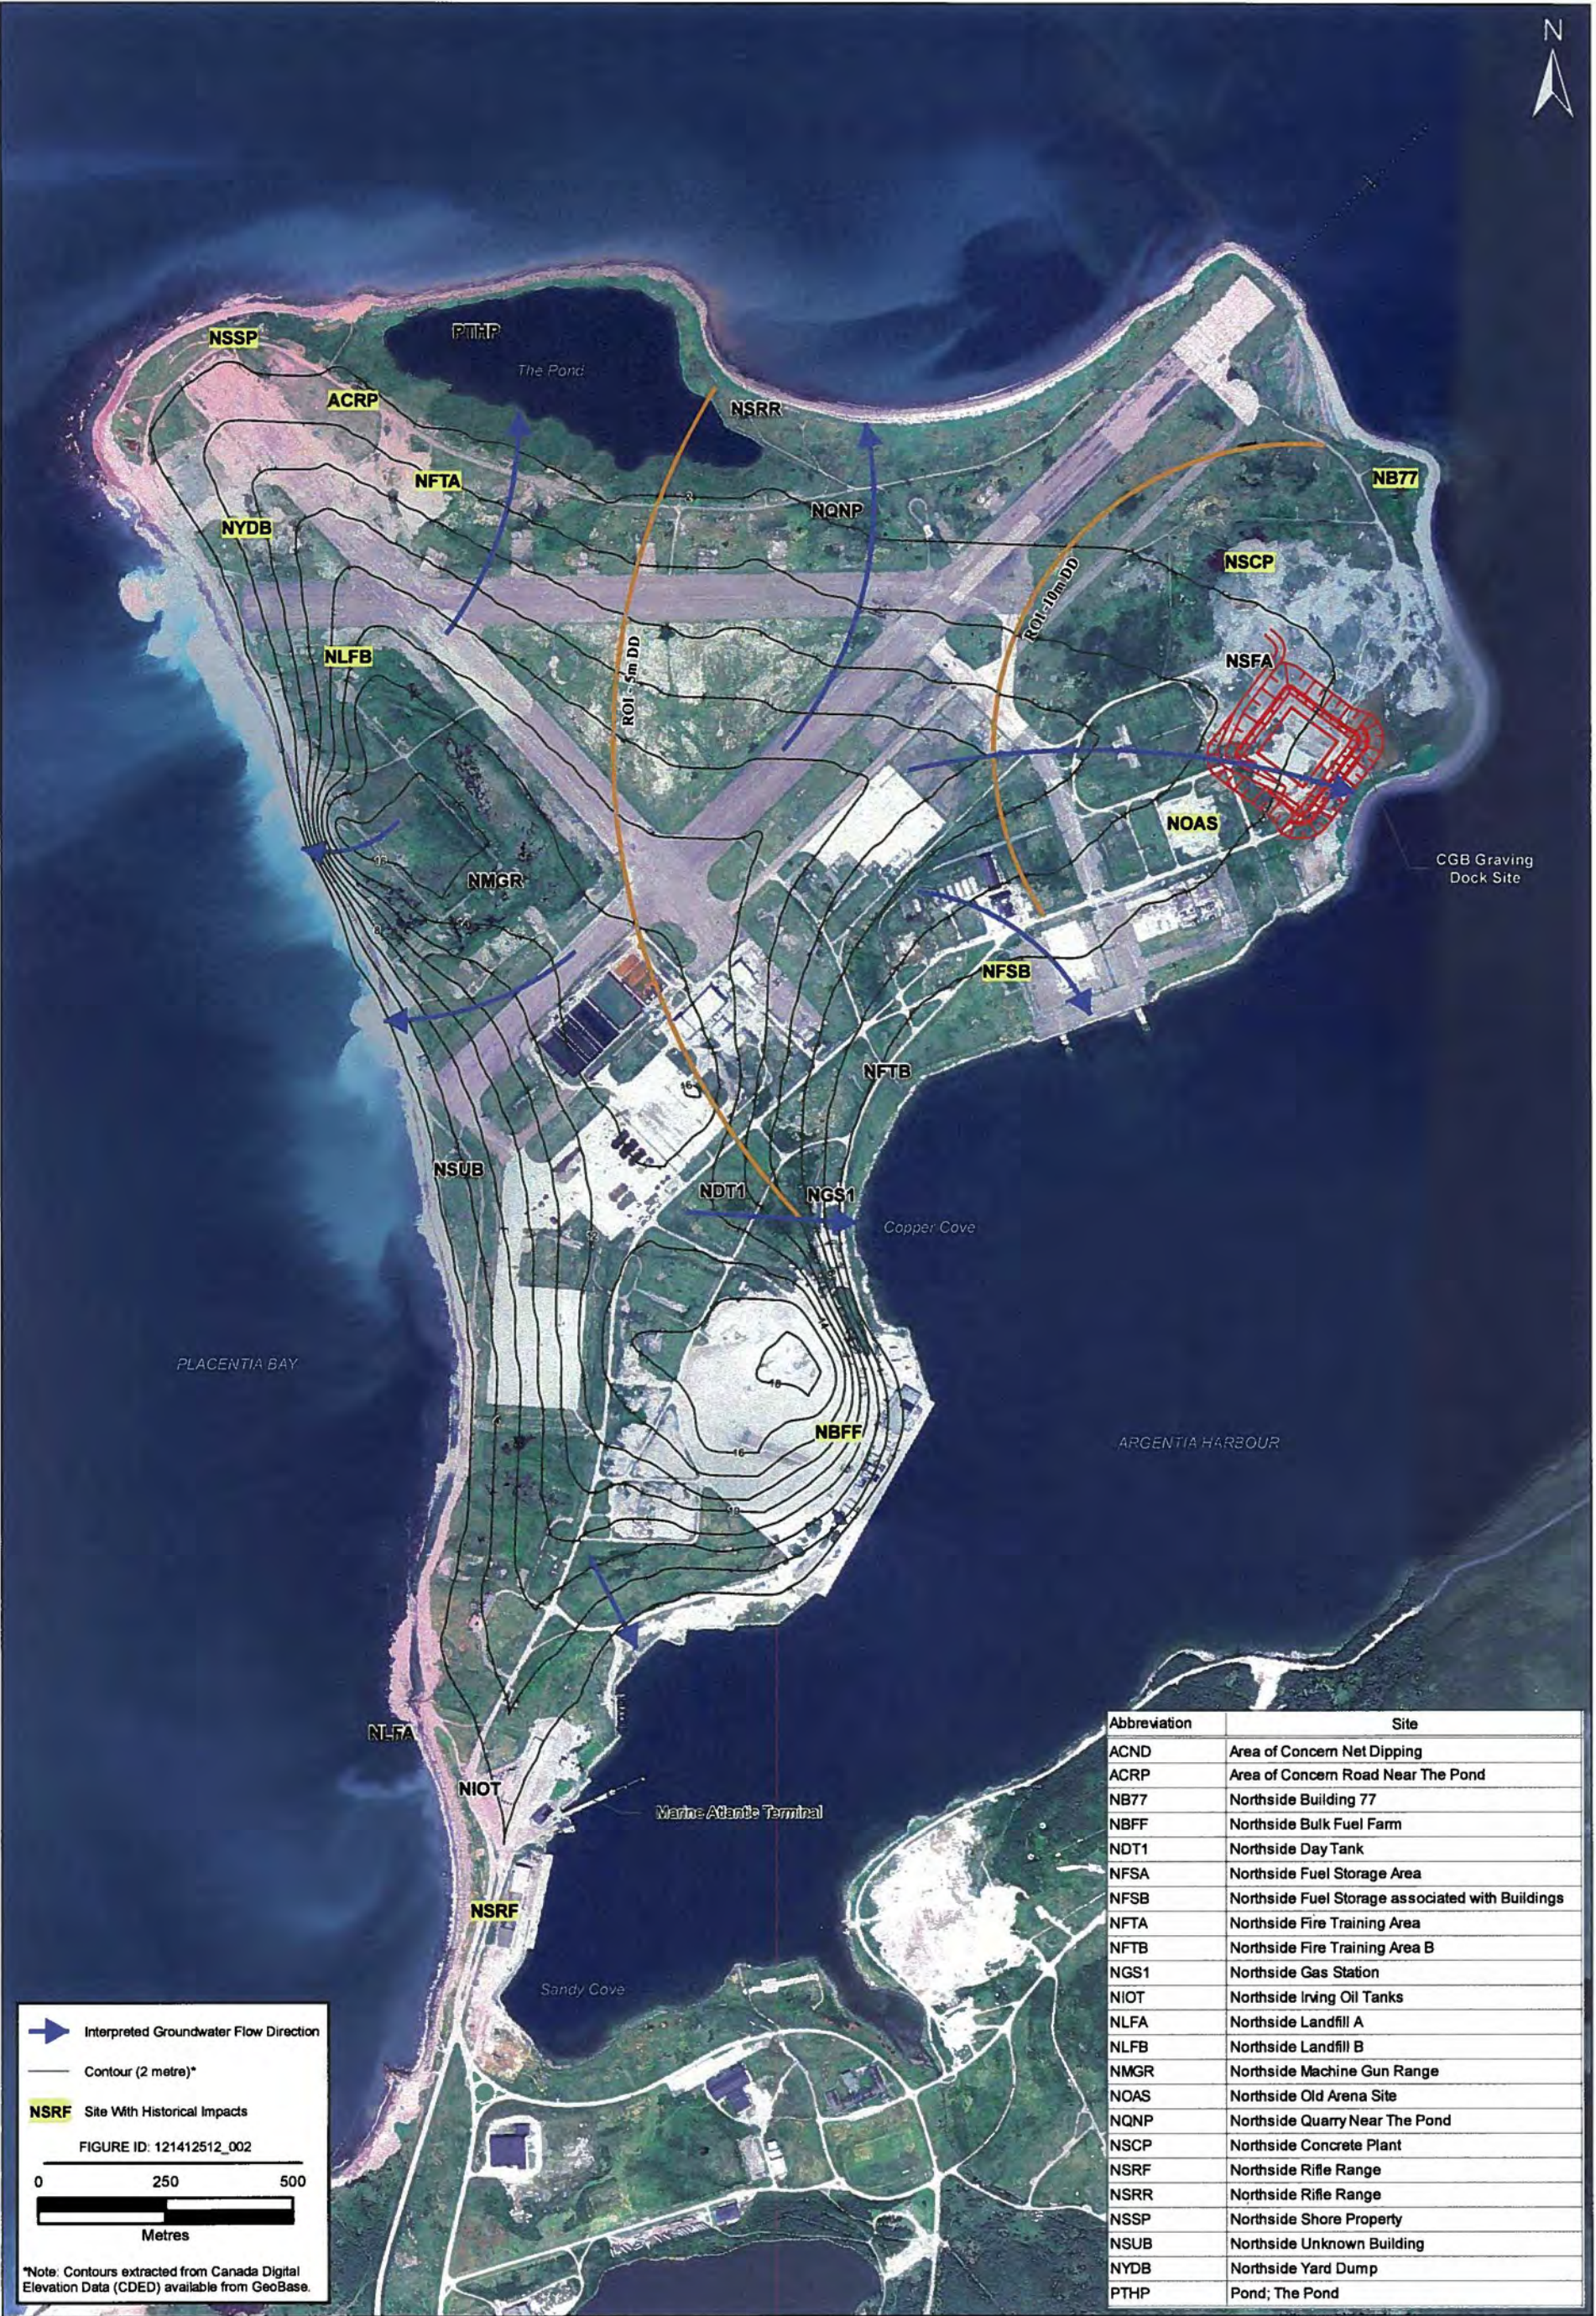
Property-wide environmental investigations of the former NAVFAC were carried out under the direction of PWGSC from 1993 to 1995, and included Phase I through Phase IV Environmental Site Assessments (ESAs) and human health and ecological risk assessments (HHERA). These studies identified various contaminated sites on the Argentia Northside Peninsula due to former military operations and waste disposal activities. During the environmental investigations, the contaminated sites were given letter codes (e.g., NFSA) based on the local site names used formerly at the Argentia NAVFAC property. These letter codes were used by PWGSC in naming the monitoring wells, and are referred to in this report. For reference, the contaminated sites within the study area are labeled along with their corresponding letter codes on Drawing No. 121412512-EE-02 in Appendix A (Dillon Consulting Ltd., 2010).

The proposed CGS graving dock site is located in the northeast portion of the Argentia Northside peninsula, as shown on Drawing Nos. 121412512-EE-01 and -EE-02 in Appendix A. The Northside peninsula is a roughly triangular-shaped low-lying peninsula that is surrounded on all sides by the ocean, and is connected to the mainland by a narrow isthmus at the south end in the area of Sandy Cove. The site is bordered to the north, west and south by vacant land and to the east by the waters of Argentia Harbour. Access to the site is via Provincial Highway Route 100, which ends at the Marine Atlantic Ferry Terminal at the south end of the peninsula, followed by a series of paved and gravel roads on the peninsula remaining from historical operations.

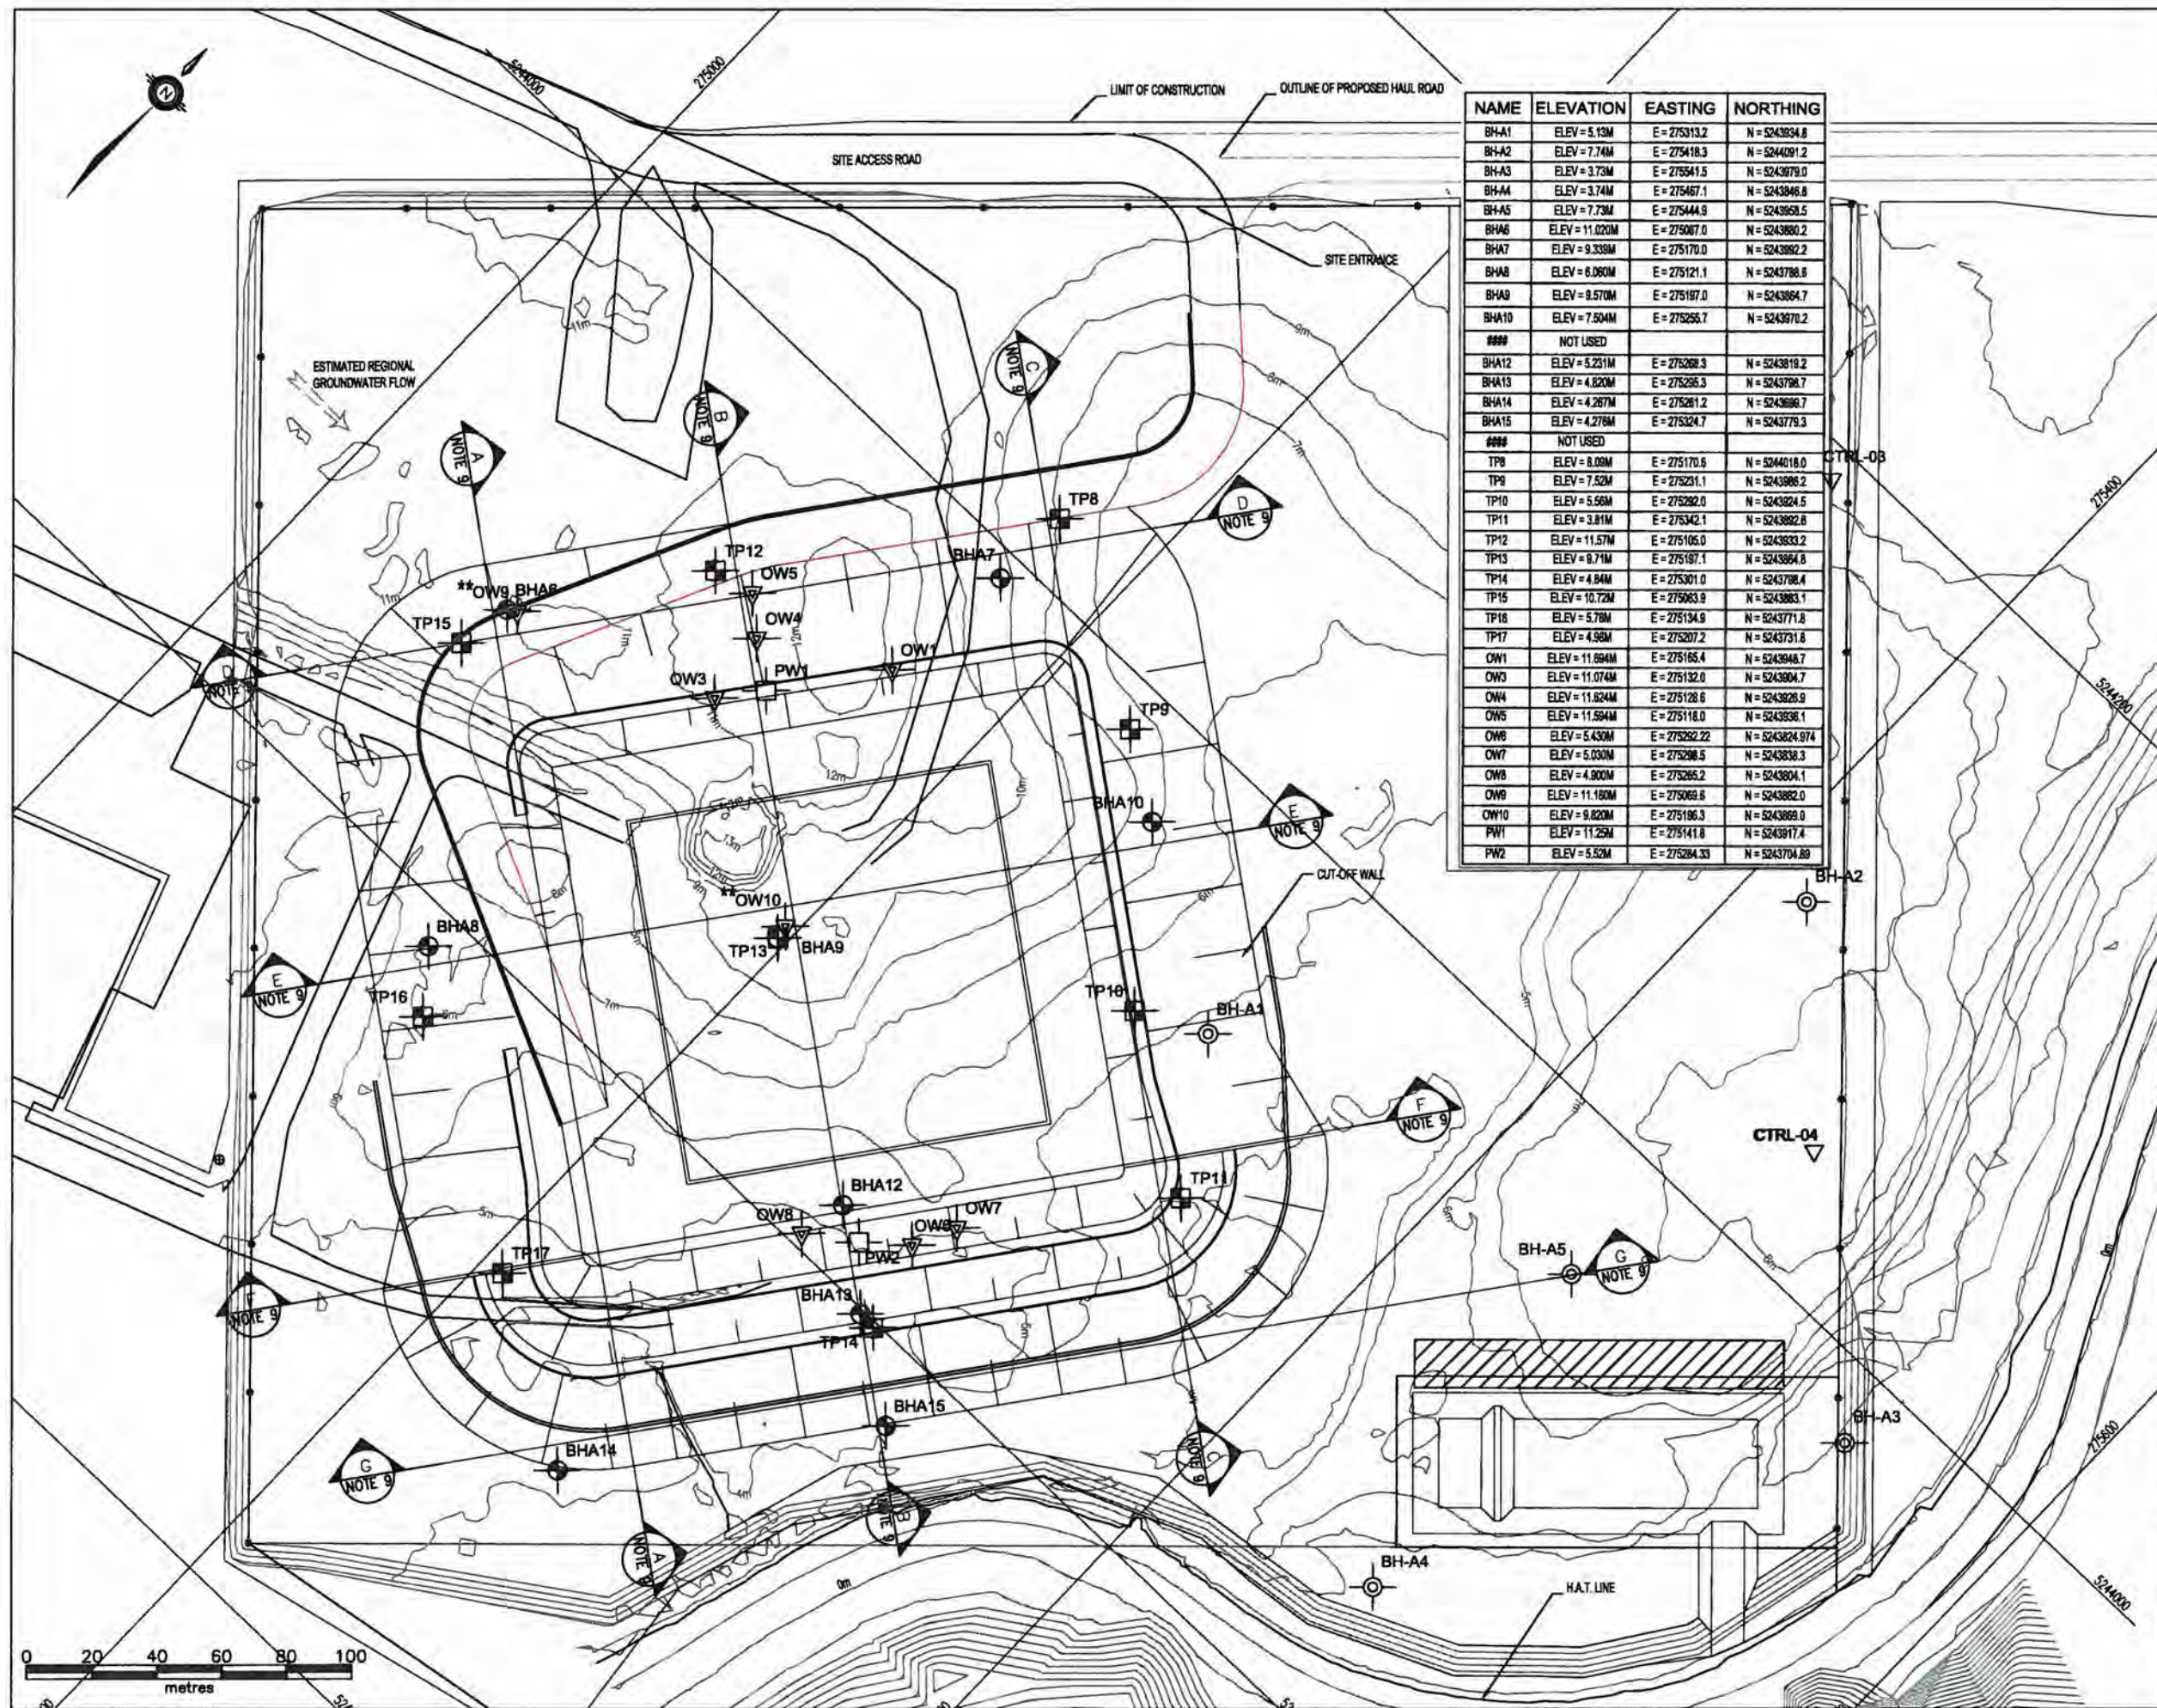
SCALE:	1:2000	DATE:	MAR 28, 2013
DRAWN BY:	N.M.	CHECKED BY:	
EDITED BY:		REVIEWED BY:	0
DRAWING No:	121412512-EE-03		
CAD FILE:	121412512-EE-02.DWG

A total of nine observation wells (OW) were drilled and completed as monitor wells by Golder Associates between November 24 and December 21, 2012 for use during the hydrogeological investigation. Details regarding the drilling of these observation wells are provided in Golder (2012a), along with borehole logs presenting subsurface conditions encountered at the borehole locations, as well as specific monitor well construction details. Table C.1 in Appendix C summarizes the borehole and monitor well construction details. The locations of the observation wells completed as part of Golder's 2012 geotechnical program are shown on

Drawing No. 121412512-EE-03 in Appendix A. Two well depths were installed, including six (6) wells (OW1, 3, 4, 5, 9 and 10) to an average depth of 21.3 m to monitor conditions near the base of the proposed excavation, and three (3) wells (OW6, 7 and 8) to an average depth of 41.1 m to monitor conditions below the CGS graving dock excavation and supplement the geotechnical borehole wells. With the exception of OW6 (6.1 m screen), each well was constructed with 51 mm diameter, fully-penetrating, No. 10 Slot PVC screens ranging in depth from 18.2 m to 22.9 m, set in silica sand packs in the 200 mm diameter boreholes.
