**ENQUIRY REPORT  
ICE INCURSION INCIDENT *SEAROSE* FPSO  
July 26, 2018**

**Prepared by:**  
**Veronica Warren, C-NLOPB Safety Officer**  
**Assisted by:**  
**John Pennell, C-NLOPB Environmental Compliance Officer; and**  
**Darrell Gover, C-NLOPB Environmental Compliance Officer**

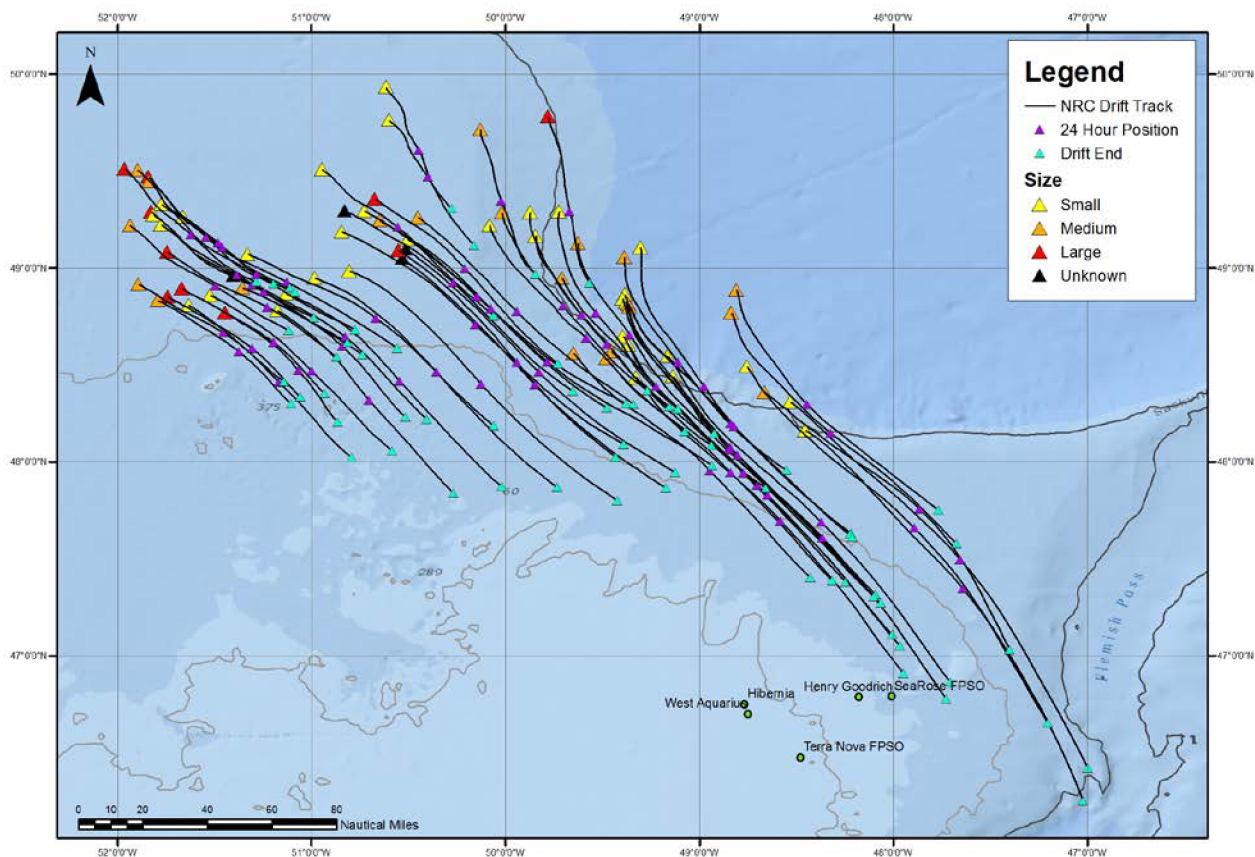
**Figure 1: NRC Drift Model**

The ice flight on March 26, 2017 detected a total of 68 icebergs to the north of the facilities, which would be pushed toward the field by Tuesday March 28. The *SeaRose* Marine Supervisor stated in his interview that the bergs were approximately 90 to 120 NM away at that time and waves were forecasted to be 12 m significant with max wave height 18 to 19 m. The NRC Drift Model produced at that time (Figure 1) showed a southeast drift toward the operating facilities.

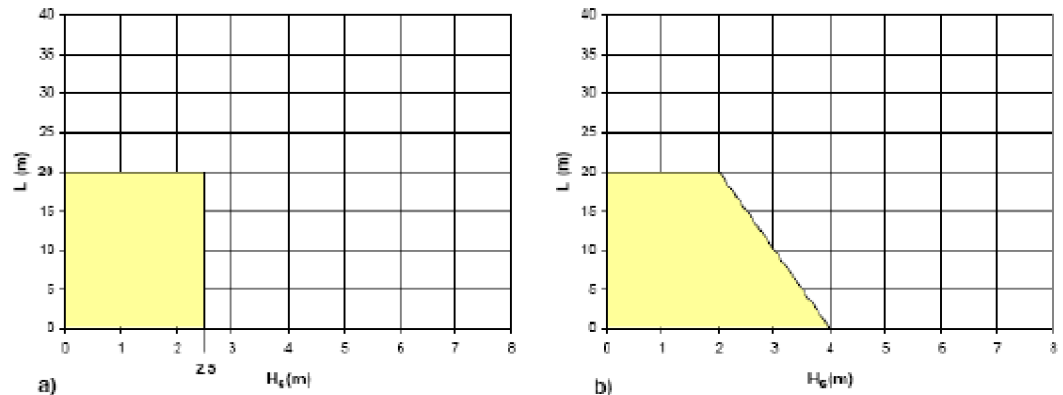
**Figure 5-4 A & B - Criteria for combinations of L and H that satisfy the serviceability condition. Report # WR-HSE-RP-0151**

Criteria for maximum iceberg waterline length and significant wave height, that satisfy the serviceability condition, are illustrated in Figure 5-4. Figure 5-4 A illustrates the criterion in which icebergs of waterline lengths less than 20 m, together with significant wave heights less than 2.5 m, are acceptable. An alternative region is given in Figure 5-4 B in which the maximum significant wave height is increased for icebergs less than 20 m. Restricting the iceberg waterline length to less than 20 m minimizes the risk of an iceberg making contact with the FPSO bilge keel. Icebergs having waterline lengths less than 5 m were not considered in the analysis and do not pose a significant threat to the FPSO.

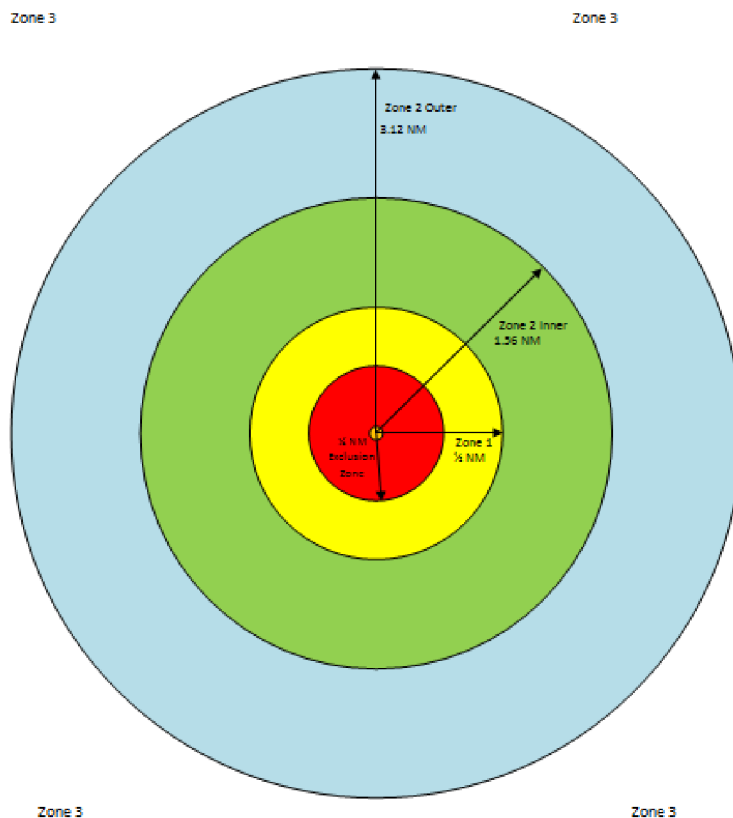
Figure 4: FPSO Ice Zone

Husky's IMP has three geographical ice zones created around the *SeaRose* to dictate actions to be taken to ensure the safety of personnel, equipment and the environment. See Figure 4.

About 2345 hrs, March 28, 2017, the *SeaRose* OOW recorded berg 011 as being 6.3 NM away from the *SeaRose* with a CPA of 2.2 NM and a TCPA at 0500 hrs on March 29. This CPA is intersecting Zone 2. There was, however, no record that it was recognized or conveyed to the OIM that berg 011's CPA intersected Zone 2. Figure 4 below shows the *SeaRose* Ice Zones (not to scale) as calculated by the enquiry team using data derived from Husky's records (Refer to Appendix 1 for Zone calculations for berg 011). Zone 2 was calculated by the enquiry team to be 3.12 NM using the last  $T_{Time}$  provided of 2 hours and 40 minutes and a berg speed of 1.2 kt (Appendix 1).

At 0145 hrs the OIM gave instructions to shut in the two remaining wells, CP1 and CP6, both located within the central drill centre, to reduce the *SeaRose*'s  $T_{Time}$ . This was in accordance with the IMP as the iceberg has not yet reached Zone 2. The OIM also instructed the control room to proceed to and hold at step five of the disconnect sequence.

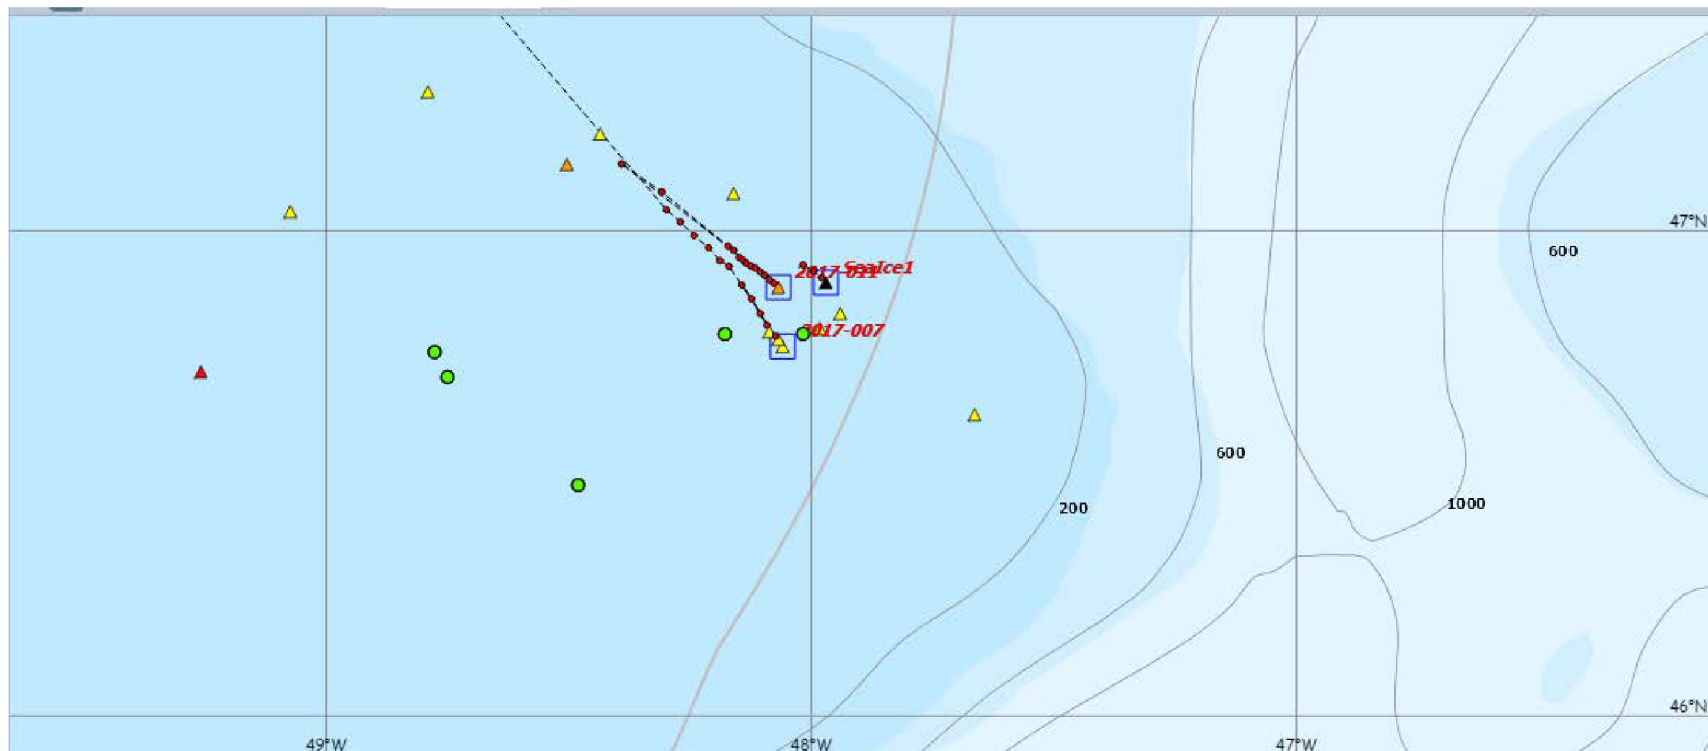
2017-007 is passing east of HGR and west of *SeaRose*. 2017-011 will pass east of both facilities. The leading patch of sea ice will also pass to the east of both facilities.

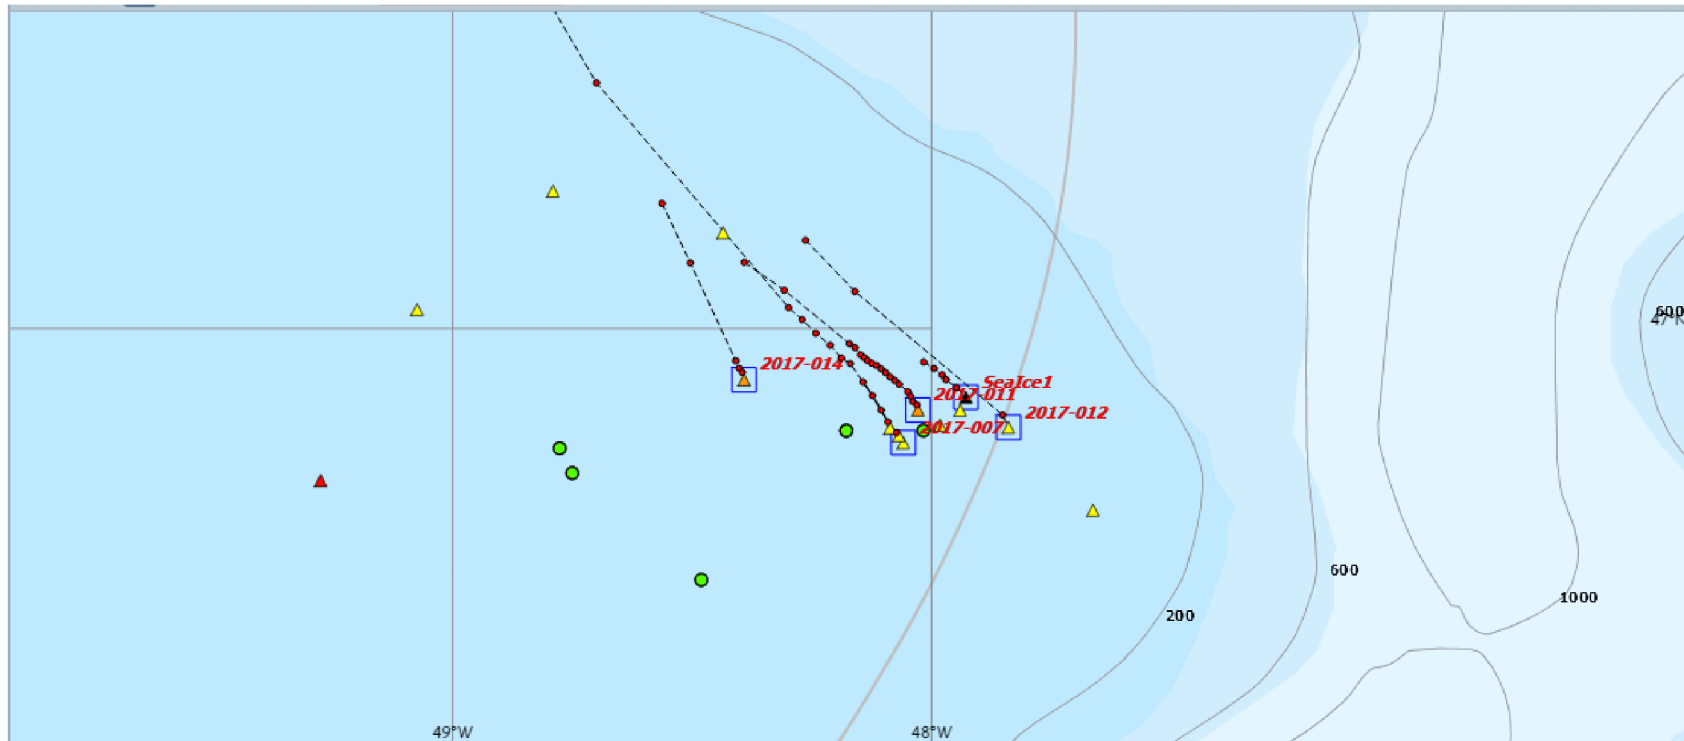
2017-007 is passing east of HGR and west of *SeaRose*. 2017-011 will pass east of the *Henry Goodrich*, at present it will pass slightly to the east of *SeaRose* it will pass. 2017-012 will pass east of both facilities. 2017-014 will pass west of both facilities, and the leading patch of sea ice will also pass to the east of both facilities.

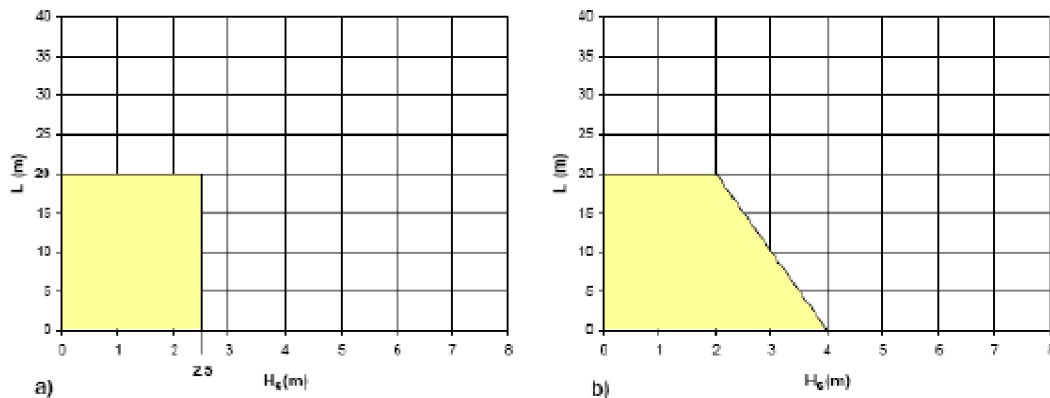
**Figure 5-4 A & B - Criteria for combinations of L and H that satisfy the serviceability condition. Report # WR-HSE-RP-0151**

Criteria for maximum iceberg waterline length and significant wave height, that satisfy the serviceability condition, are illustrated in Figure 5-4. Figure 5-4 A illustrates the criterion in which icebergs of waterline lengths less than 20 m, together with significant wave heights less than 2.5 m, are acceptable. An alternative region is given in Figure 5-4 B in which the maximum significant wave height is increased for icebergs less than 20 m. Restricting the iceberg waterline length to less than 20 m minimizes the risk of an iceberg making contact with the FPSO bilge keel. Icebergs having waterline lengths less than 5 m were not considered in the analysis and do not pose a significant threat to the FPSO.
